**CASE STUDY**

**CRAY BRIDGE REPLACEMENT  
SCOTLAND**

Cray Bridge is located approximately 30 miles north of Perth just off the A93 in the Scottish Highlands. The contract involved the complete replacement of the bridge which is situated between two very tight bends on the narrow B951 as it spans the Shee Water.

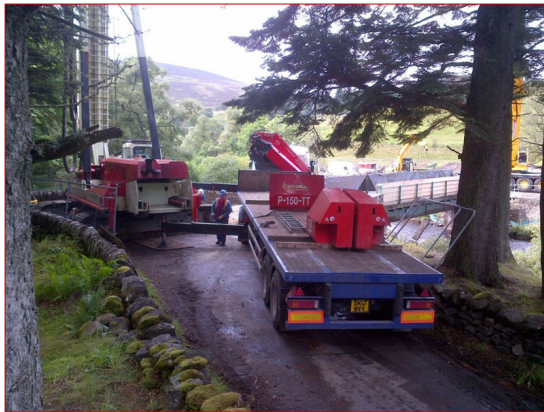
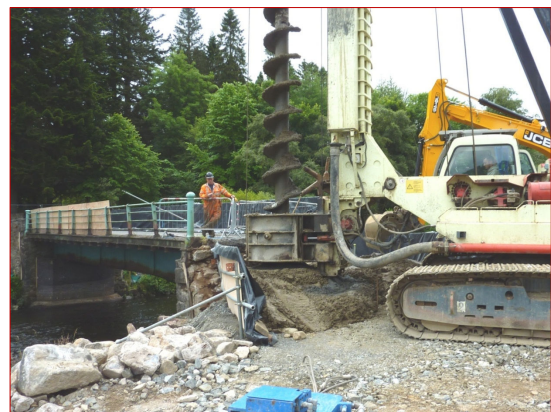
In order to minimize the risk of early refusal, the piles were installed using a powerful high torque Llamada P-150TT CFA piling rig from our own fleet. The rig has a maximum drilling torque of 27 tonne metres and an operating weight of 102 tonnes. Working space was near non-existent.
